Delaware River
Joint Toll Bridge
Commission

SEVENTIETH ANNUAL INSPECTION REPORT 2007

**RE: Consulting Engineer's Seventieth Annual Inspection Report-2007
DRJTBC Contract No. C-07-02A
Our Project Number 708070022**

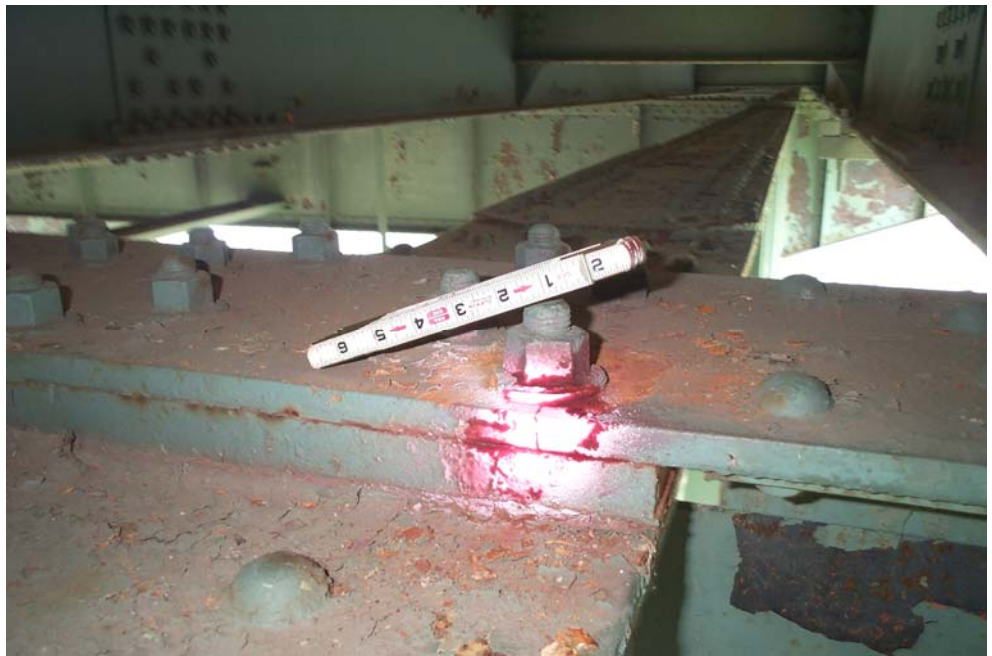
PHOTO 3 Crack in the tie plate over the south girder at the first floorbeam east of Pier 5, looking east. The crack is arrested by a tie plate connection bolt hole and there are no signs of crack propagation.

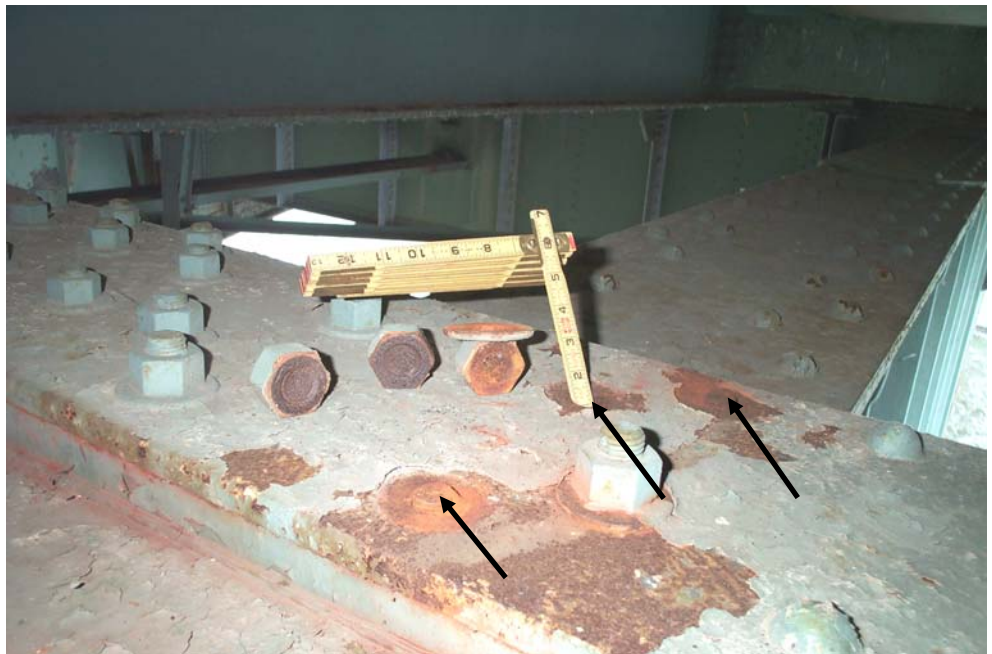
PHOTO 4 3 of 8 connection bolts are sheared at the tie plate connection over the north girder at the floorbeam at Pier 8, looking west.

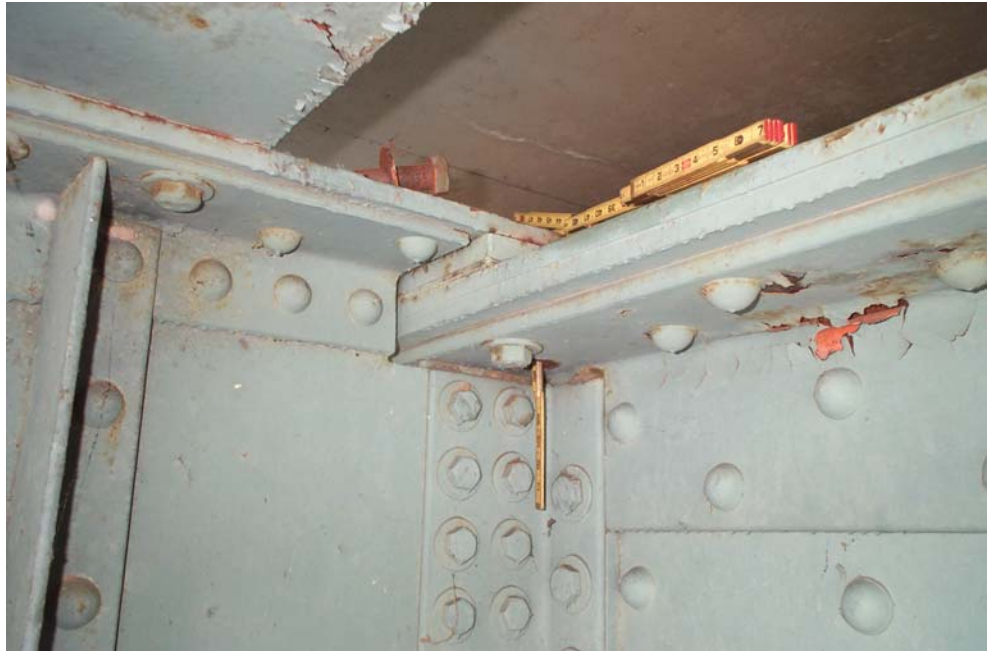
PHOTO 5 1 of 8 connection bolts is sheared at the tie plate connection over the north girder at the first floorbeam to the east of Pier 8, looking east.

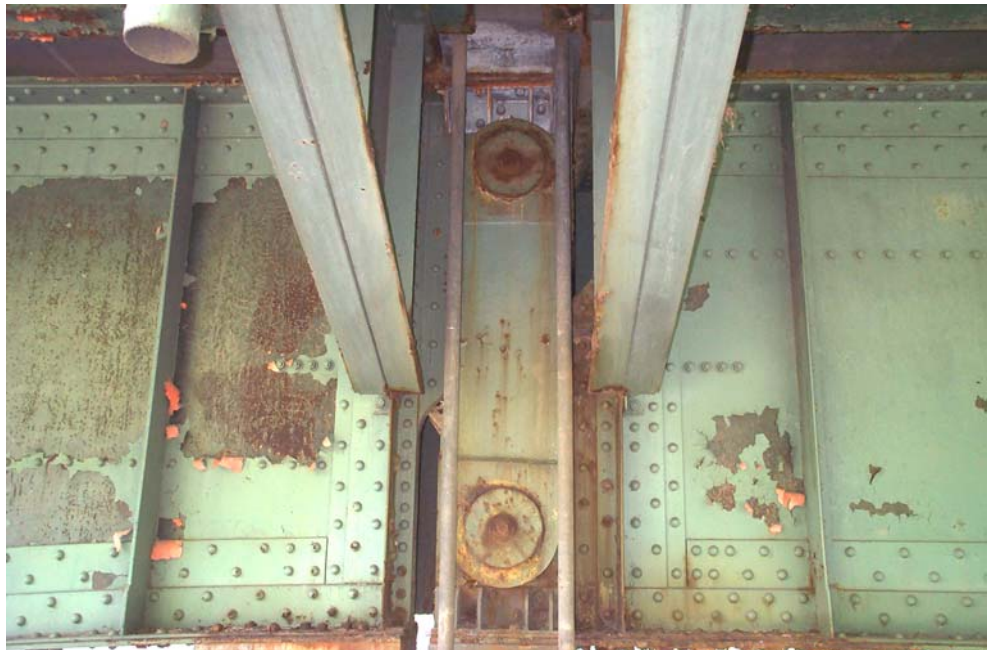
PHOTO 6 General view of the pin and hanger assembly (North girder at Span 1 shown), looking south. Note the light to moderate rust throughout assembly and seismic retrofit.

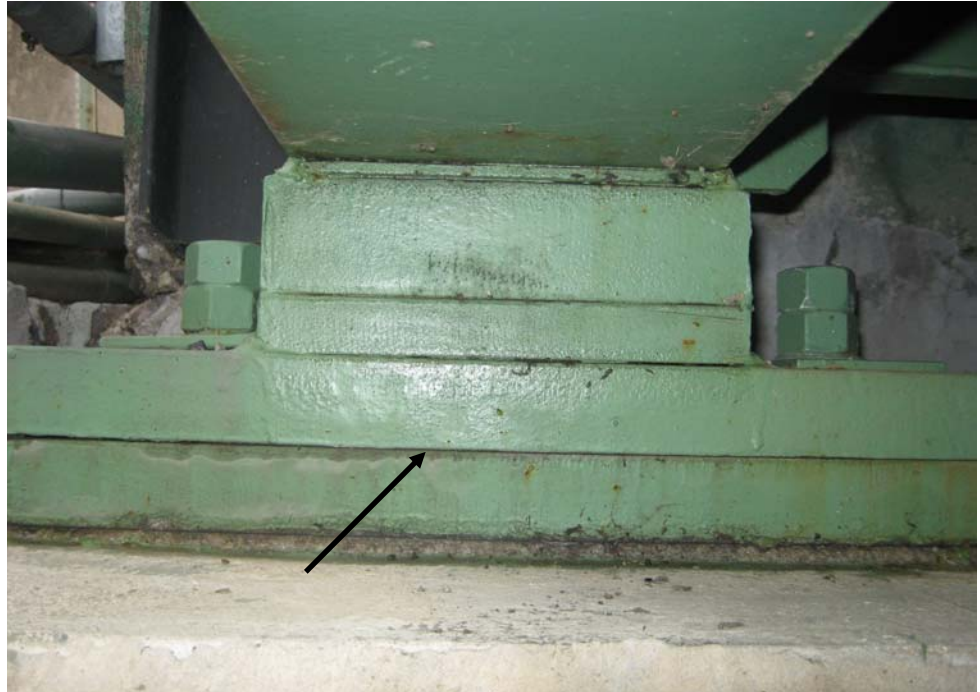
PHOTO 1 General view of the south fascia sidewalk stringer bearing, looking west. Note there is no sliding plate or gap between the masonry plate and sole plate.

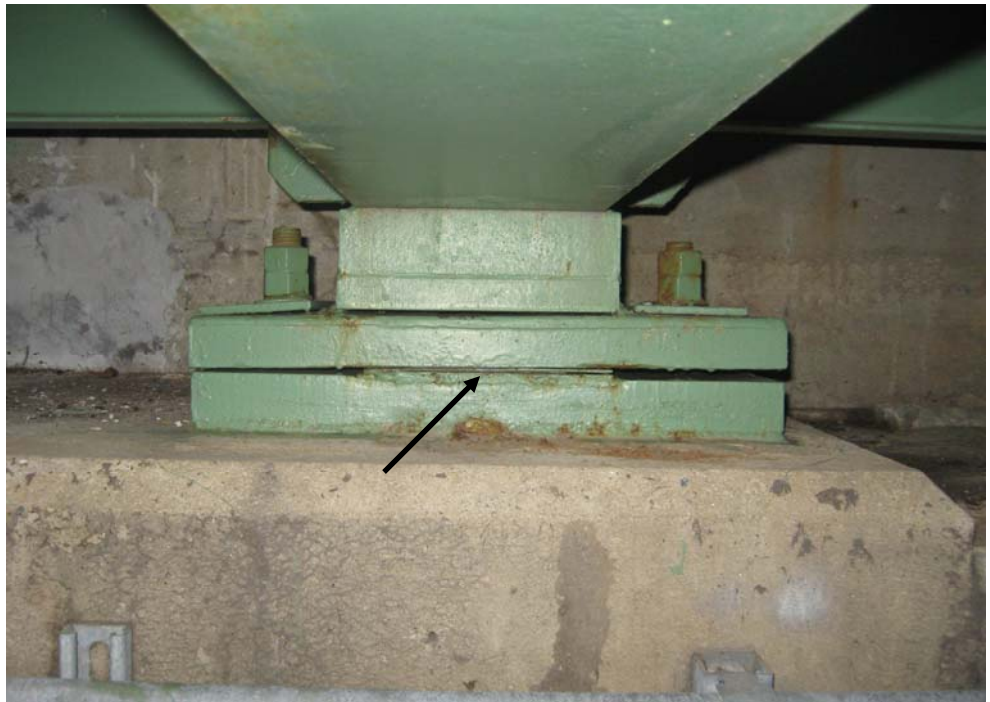
PHOTO 2 General view of the Sidewalk Stringer 2 (from south) bearing, looking west. Note the sliding plate between the masonry plate and sole plate.
