Delaware River
Joint Toll Bridge
Commission

SEVENTIETH ANNUAL INSPECTION REPORT 2007

**RE: Consulting Engineer's Seventieth Annual Inspection Report-2007
DRJTBC Contract No. C-07-02A
Our Project Number 708070022**

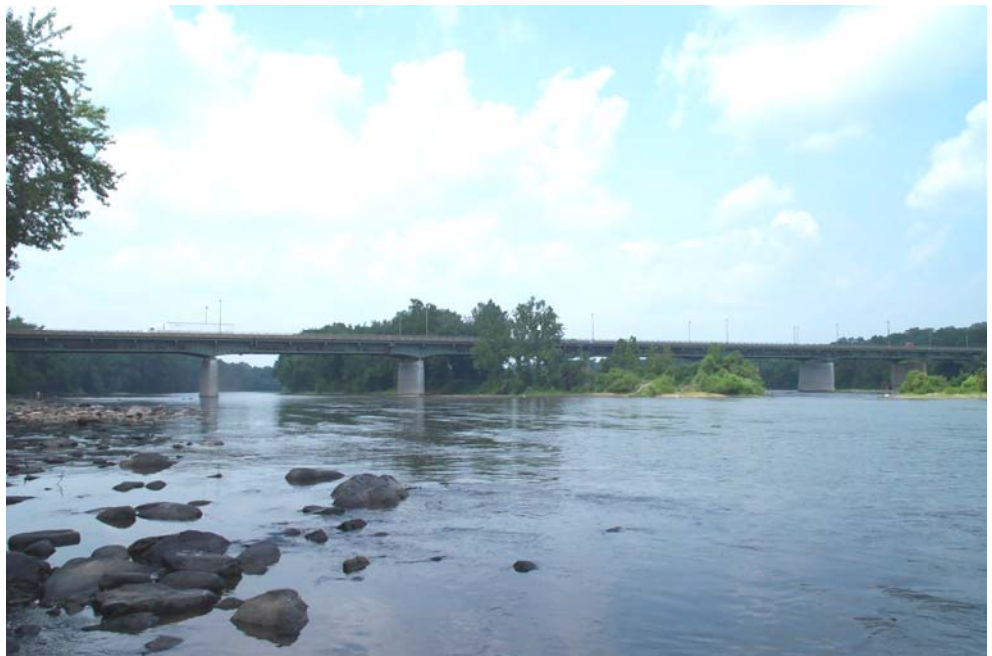
PHOTO 1 South elevation, looking north.

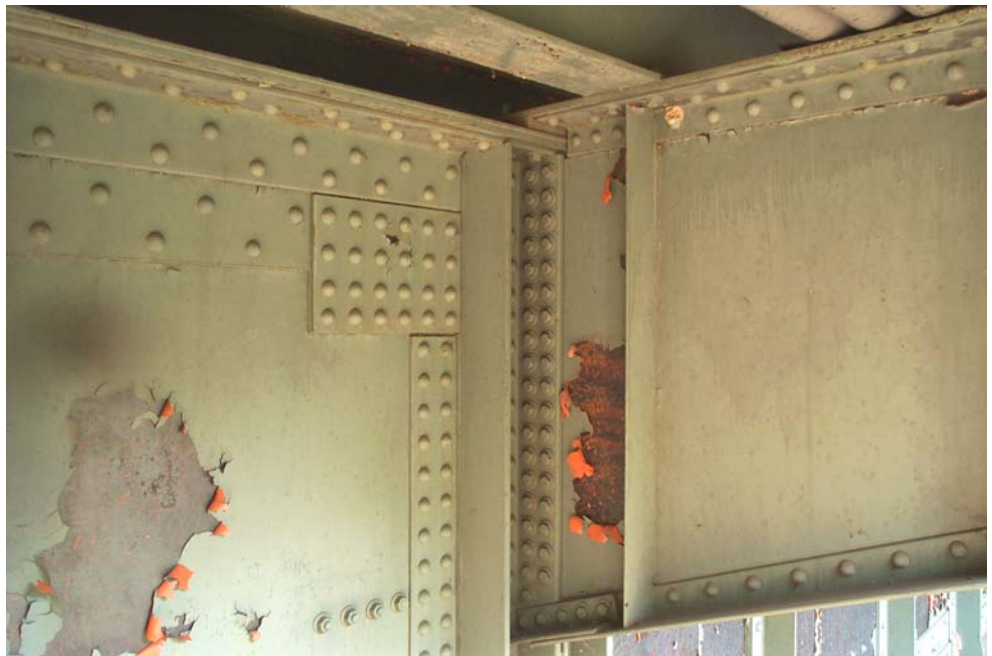
At each floorbeam location there are cantilever brackets supporting the roadway / shoulder. The cantilever brackets consist of welded plates with the top flange of the cantilever brackets extending across the top of the main girder top flange transitioning into a tie plate, which is connected to the interior floorbeam top flange with a bolted connection (See Photo 2). The cantilever bracket supports two roadway stringers.

PHOTO 2 Typical Cantilever bracket (Floorbeam 3 at Span 1 shown), looking northeast.
