# 2016 TOLL-SUPPORTED BRIDGE ANNUAL INSPECTION REPORT

Contract No. C-684A

*Prepared By*  
**Cherry, Weber  
& Associates, PC**  
MEMBER OF THE VAN CLEEF ENGINEERING GROUP

Re: General Engineering Consultant  
2015 – 2016 Annual Inspections  
DRJTBC Contract No. C-684A  
**2016 Toll-Supported Bridge  
Annual Inspection Report**

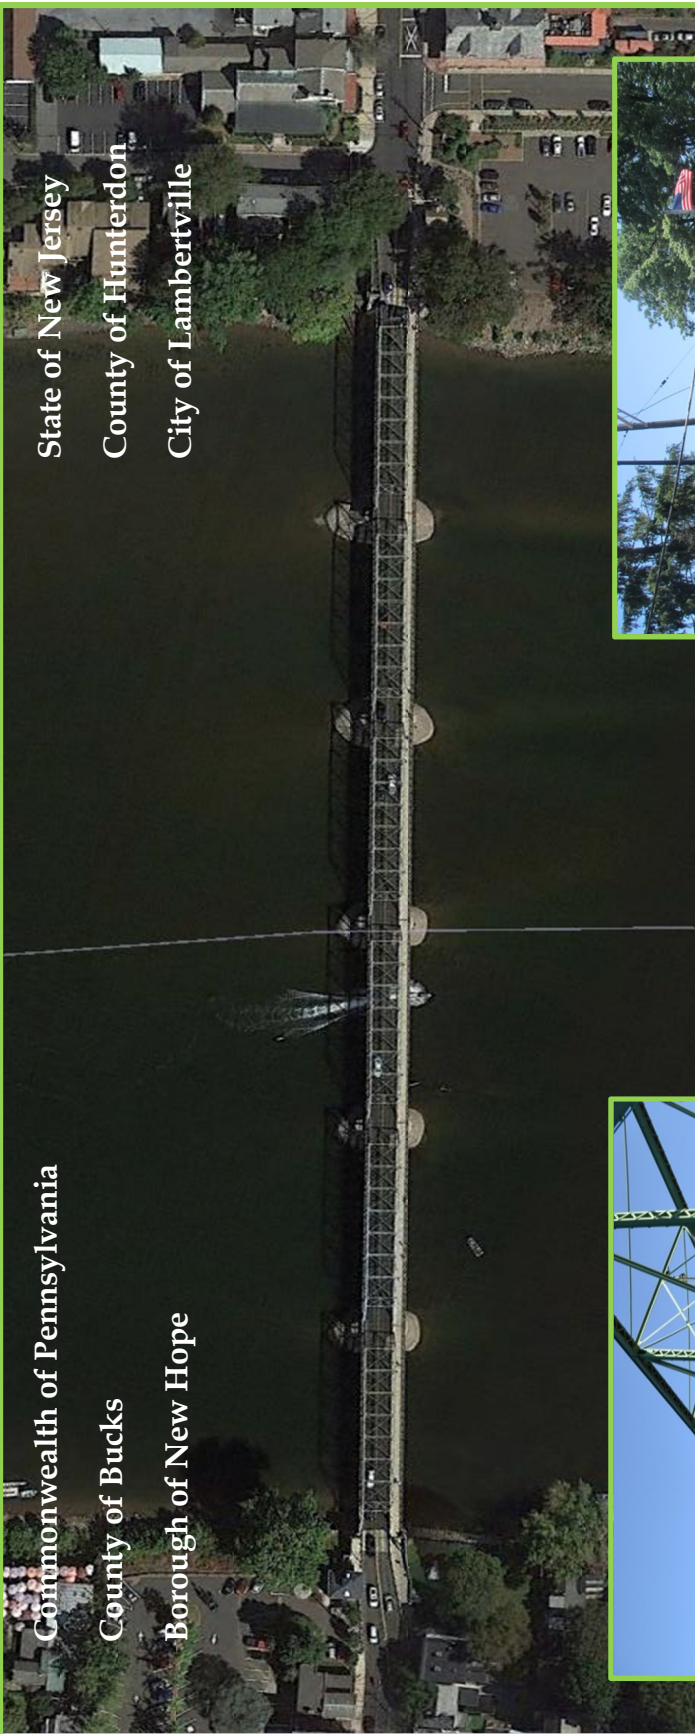
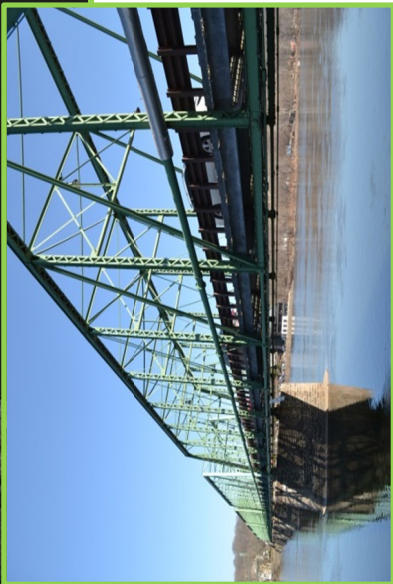
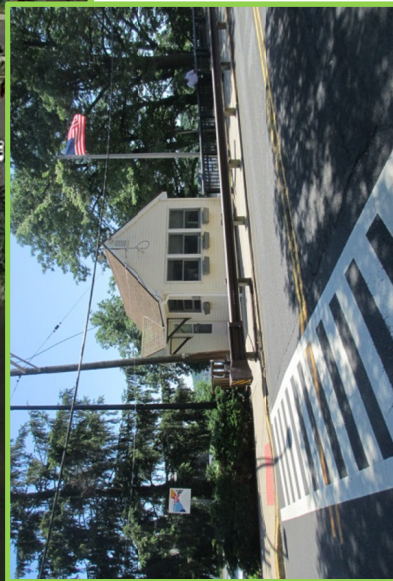
***NEW HOPE - LAMBERTVILLE***  
***TOLL-SUPPORTED BRIDGE***  
***(Structure No. 120)***

The structure, constructed in 1904, is a six span pin connected Pratt Truss with a total length of approximately 1,056 feet. The open steel grid deck provides a curb to curb width of 20 feet, 5 inches. A timber plank sidewalk, installed in 1982, and replaced in 2004 with fiberglass panels, is supported on the downstream side by steel cantilever brackets. Abutments, wingwalls and piers are ashlar faced masonry; the piers are stone filled. All substructure units are from original construction in 1814.

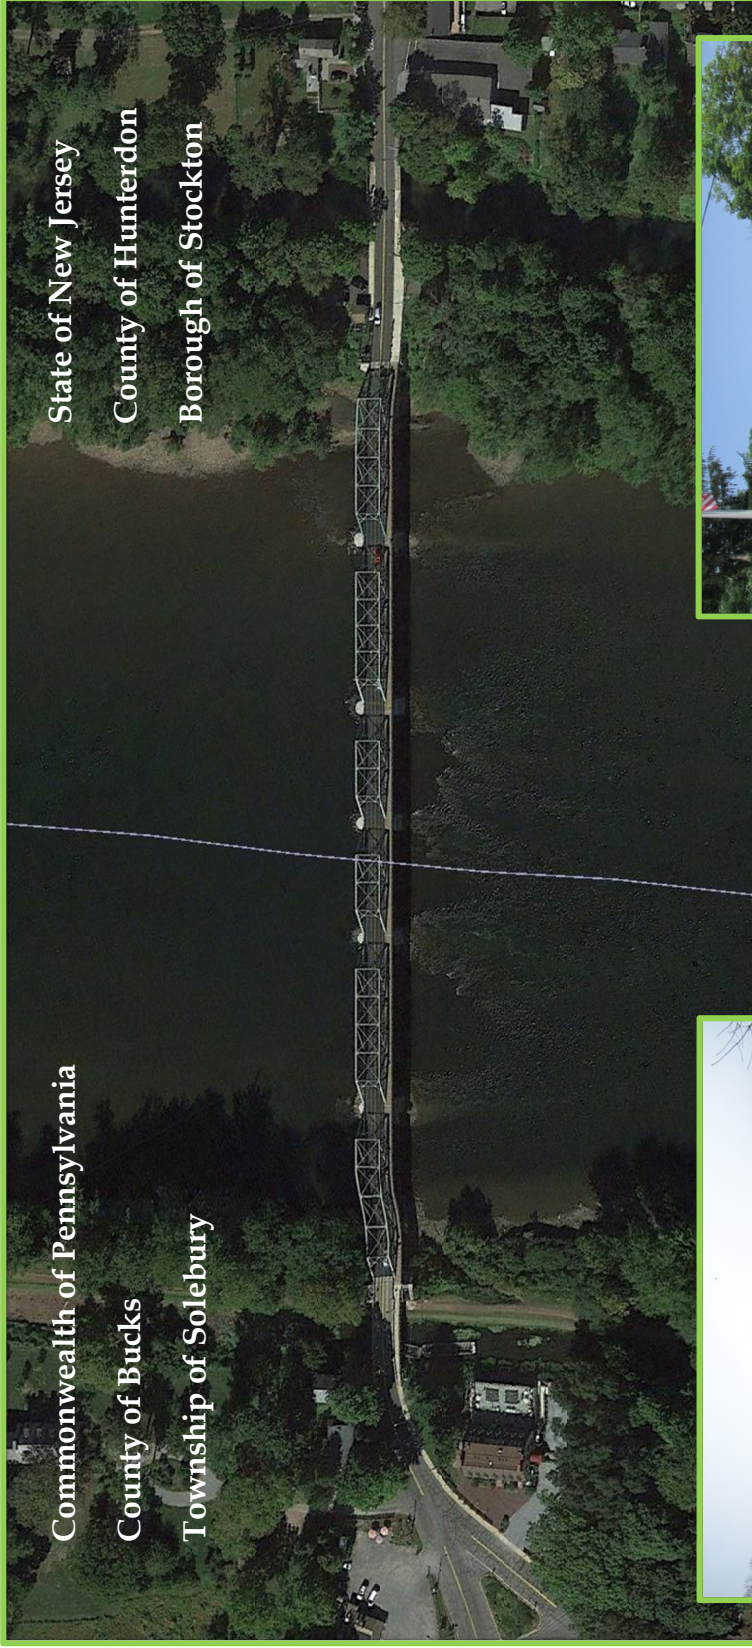
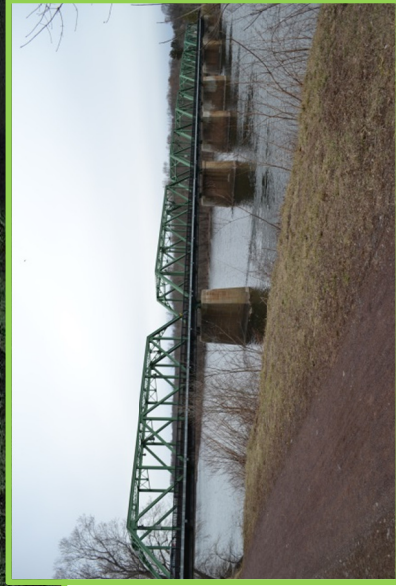
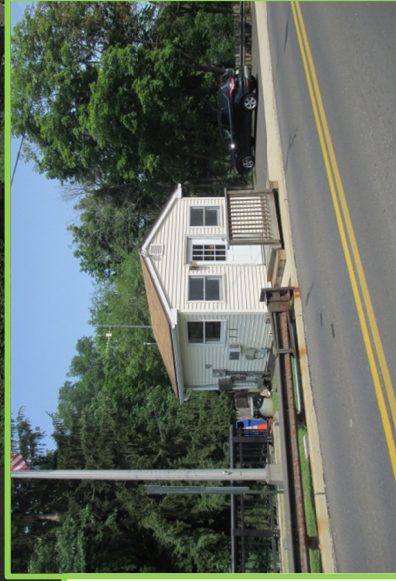
***(Structure Nos. 160 & 161)***

The bridge, opened to traffic in 1927, is a six span, riveted steel Warren Truss structure, with a total length of approximately 825 feet. The open steel grid deck provides a curb to curb width of 20 feet. In addition, a six foot timber plank sidewalk is supported on the downriver truss on steel cantilever brackets. The piers and abutments originally constructed in 1814 from random ashlar masonry are stone filled and rest upon timber crib foundations. In 1926 portions of the piers were encased with reinforced concrete.
