Delaware River
Joint Toll Bridge
Commission

MARCH 2020

Contract No. C-684A

2019 TOLL BRIDGE ANNUAL INSPECTION REPORT

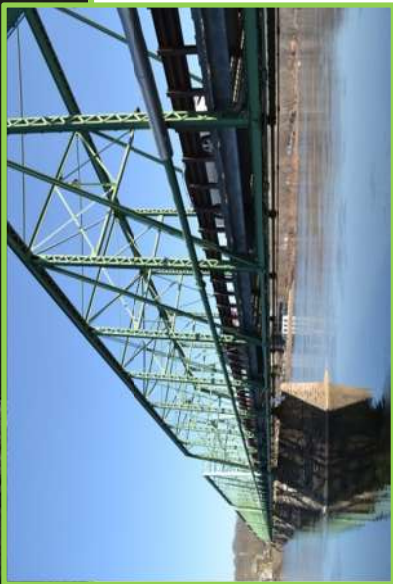
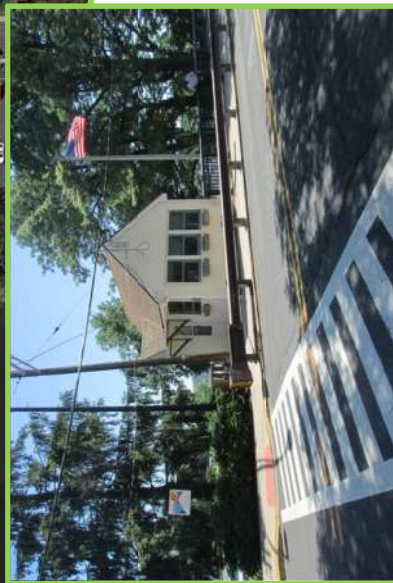
NEW HOPE - LAMBERTVILLE
TOLL-SUPPORTED BRIDGE
(Structure No. 120)

The structure, constructed in 1904, is a six span pin connected Pratt Truss with a total length of approximately 1,056 feet. The open steel grid deck provides a curb to curb width of 20 feet, 5 inches. A timber plank sidewalk, installed in 1982, and replaced in 2004 with fiberglass panels, is supported on the downstream side by steel cantilever brackets. Abutments, wingwalls and piers are ashlar faced masonry; the piers are stone filled. All substructure units are from original construction in 1814.

The superstructure is in satisfactory condition. Several north and south truss lower chord member's exhibit impact damage in Spans 1 through 5. Many truss members exhibit minor section losses that have been arrested by paint and isolated areas of rust. Areas of active rust were noted throughout the floor system and lower panel points of the north and south trusses. A missing bolt exists on the north bottom chord between L0 and L1 in Span 4.

The substructure above the waterline is in satisfactory condition. Areas of loose stone masonry and missing pointing were noted at the pier stems and abutment breastwall and backwalls. The bridge seats and upstream noses have areas of concrete scaling, spalling and delamination.

The follow-up inspection on June 14, 2019 noted a localized area of missing and loose stone masonry near the bottom of the east face of Pier 5. Mortar loss was also noted near the base of Pier 1. The condition of the substructure remains satisfactory.

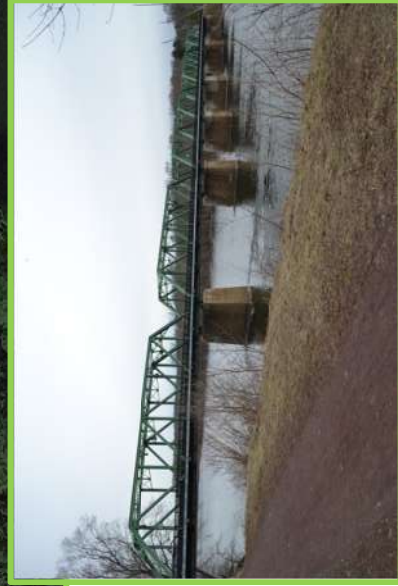
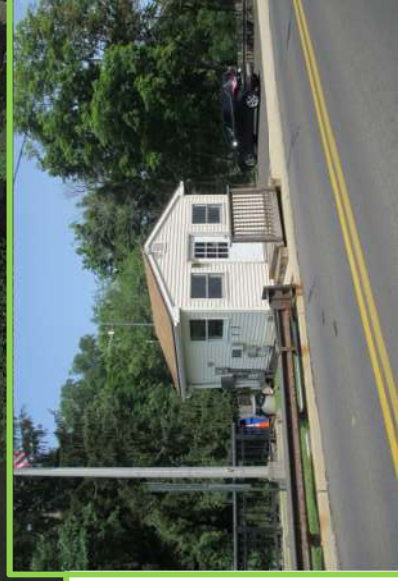
CENTRE BRIDGE - STOCKTON
TOLL-SUPPORTED BRIDGES
(Structure Nos. 160 & 161)

The bridge, opened to traffic in 1927, is a six span, riveted steel Warren Truss structure, with a total length of approximately 825 feet. The open steel grid deck provides a curb to curb width of 20 feet. In addition, a six foot timber plank sidewalk is supported on the downriver truss on steel cantilever brackets. The piers and abutments originally constructed in 1814 from random ashlar masonry are stone filled and rest upon timber crib foundations. In 1926 portions of the piers were encased with reinforced concrete.

A comprehensive rehabilitation of the Centre Bridge - Stockton Toll-Supported Bridge was completed in 2007 under Contract No. TS-429A. Rehabilitation work included floor system replacement with galvanized steel stringers and floorbeams, deck replacement, sidewalk replacement, truss bearing replacement, cleaning and painting of truss members and substructure spall repairs.
