2015 TOLL BRIDGE ANNUAL INSPECTION REPORT

February 2016

Re: General Engineering Consultant
2015 – 2016 Annual Inspections
DRJTBC Contract No. C-684A
2015 Toll Bridge Annual Inspection Report

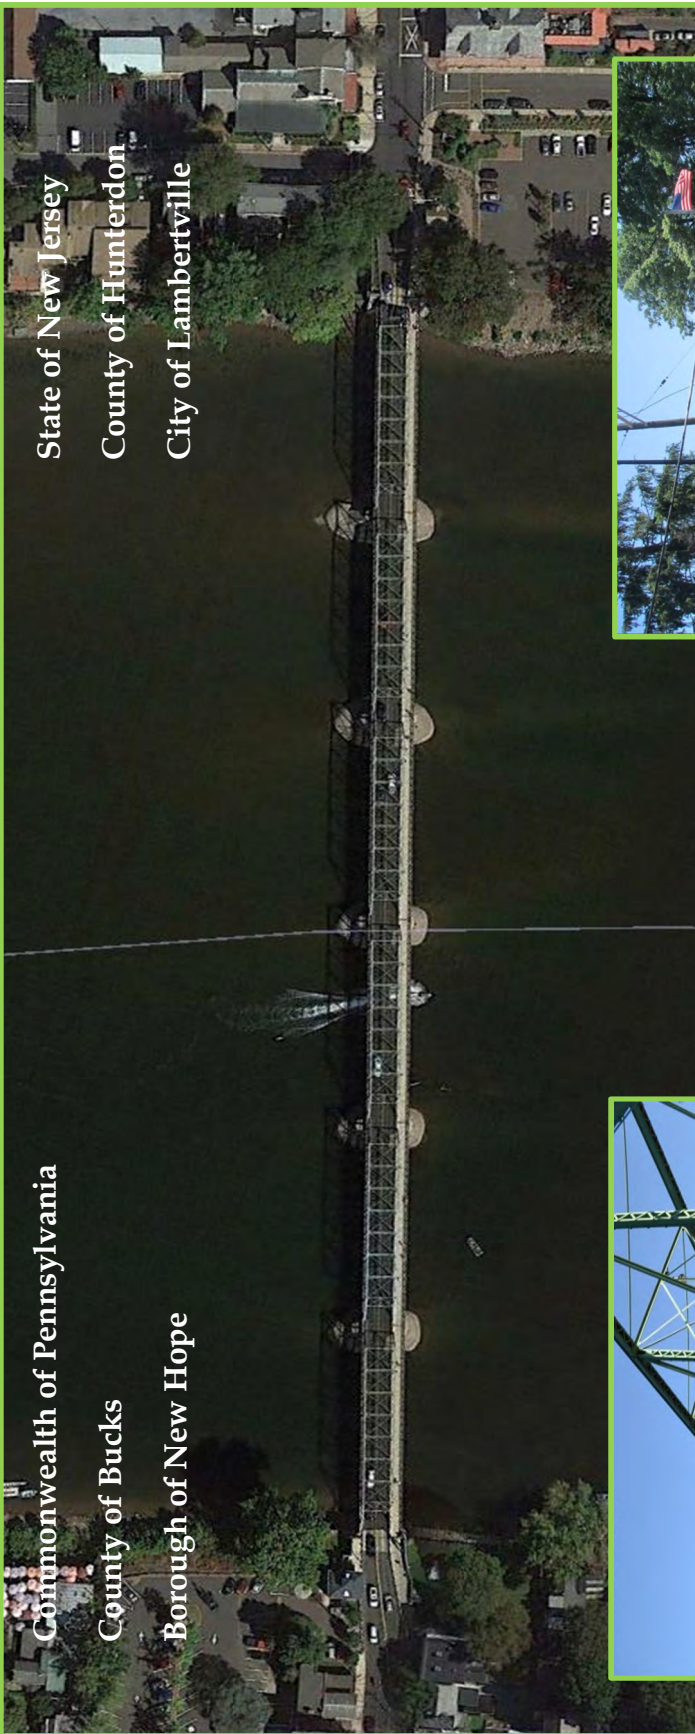
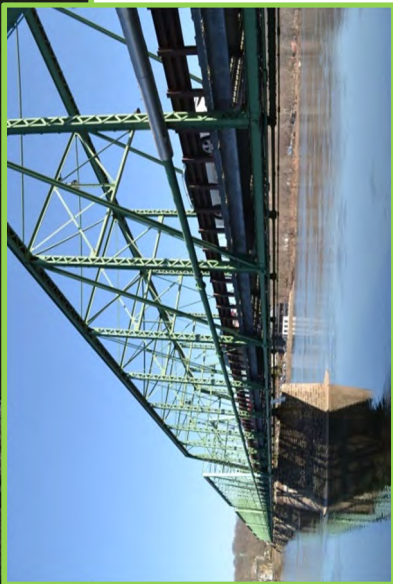
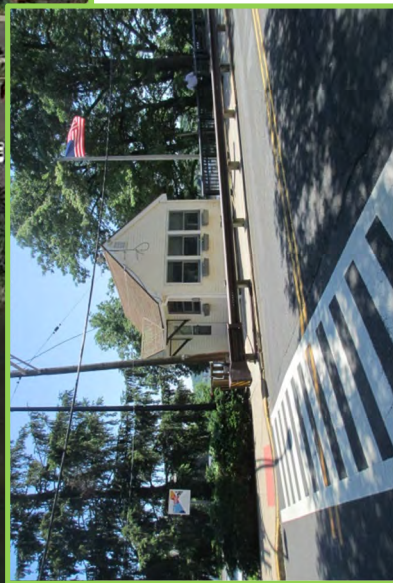
NEW HOPE-LAMBERTVILLE
TOLL-SUPPORTED BRIDGE
(Structure No. 120)

The structure, constructed in 1904, is a six span pin connected Pratt Truss with a total length of approximately 1,056 feet. The open steel grid deck provides a curb to curb width of 20 feet 7 inches. A timber plank sidewalk, installed in 1982, and replaced in 2004 with fiberglass panels, is supported on the downstream side by steel cantilever brackets. Abutments, wingwalls and piers are ashlar faced masonry; the piers are stone filled. All substructure units are from original construction in 1814.

The superstructure is in satisfactory condition. Several north and south truss lower chord member's exhibit impact damage in Spans 1 through 5. Many truss member's exhibit minor section losses that have been arrested by paint. Minor isolated areas of rust were noted throughout the floor system.

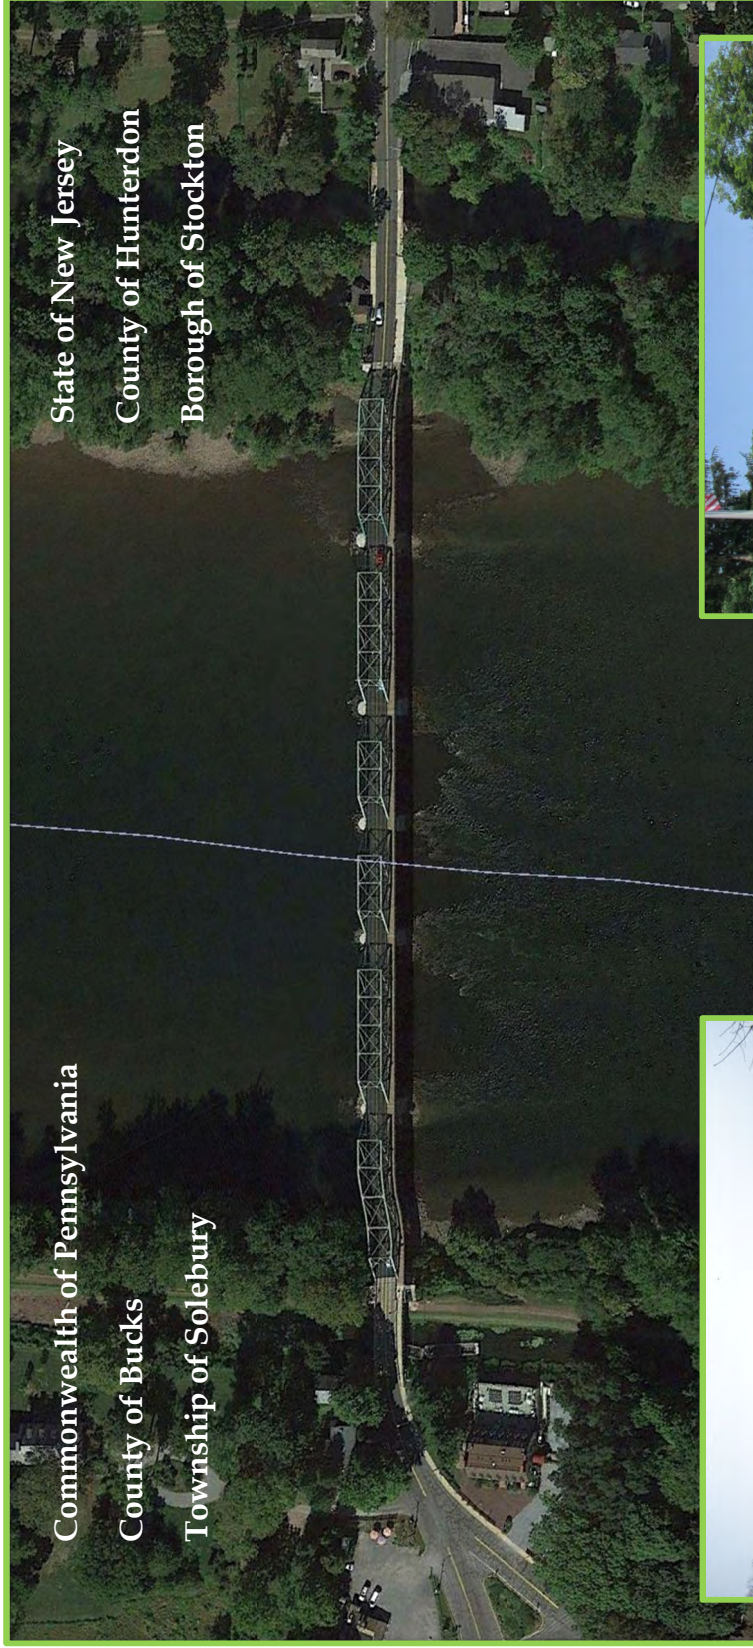
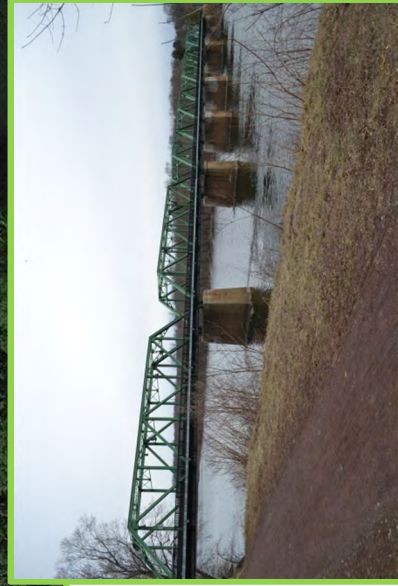
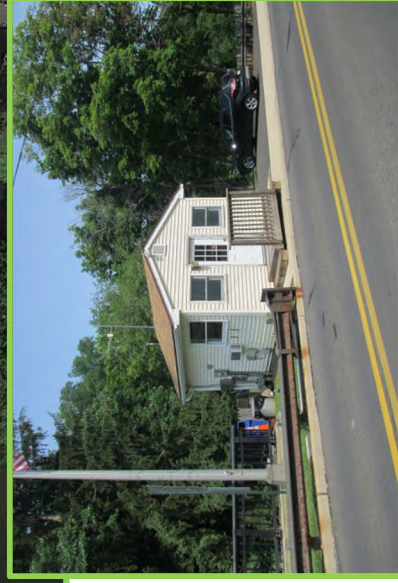
CENTRE BRIDGE-STOCKTON
TOLL-SUPPORTED BRIDGES
(Structure Nos. 160 & 161)

The bridge, opened to traffic in 1927, is a six span, riveted steel Warren Truss structure, with a total length of approximately 825 feet. The open steel grid deck provides a curb to curb width of 20 feet. In addition, a six foot timber plank sidewalk is supported on the downriver truss on steel cantilever brackets. The piers and abutments originally constructed in 1814 from random ashlar masonry are stone filled and rest upon timber crib foundations. In 1926 portions of the piers were encased with reinforced concrete.

The superstructure is in satisfactory condition. Many lower chord gusset plate's exhibit areas of 1/8" material losses. The north truss lower chord typically exhibits up to 1/8" material loss and edge loss to the horizontal top angles at both the inboard and outboard sides adjacent to connections with gusset plates. These material losses have been arrested by paint.
