**Delaware River
Joint Toll Bridge
Commission**

2023 TOLL BRIDGE ANNUAL INSPECTION REPORT CONTRACT C-757A-1

The 2023 Toll Bridge Annual Inspection Report summarizes our findings based on the 2023 Inspection of the Toll Bridges. An update of the 2022 inspection of the Toll-Supported Bridge Facilities was completed to indicate any material changes in the conclusion and recommendation report sections. All Facilities are in operating condition. The Federal Highway Administration (FHWA) has revised the definition of Structurally Deficient bridges to consider only the physical condition of the bridge when determining if a bridge is Structurally Deficient. Based on this revision, the DRJTBC no longer has any Structurally Deficient bridges. In addition, FHWA no longer tracks the Functionally Obsolete metric in their archive data.

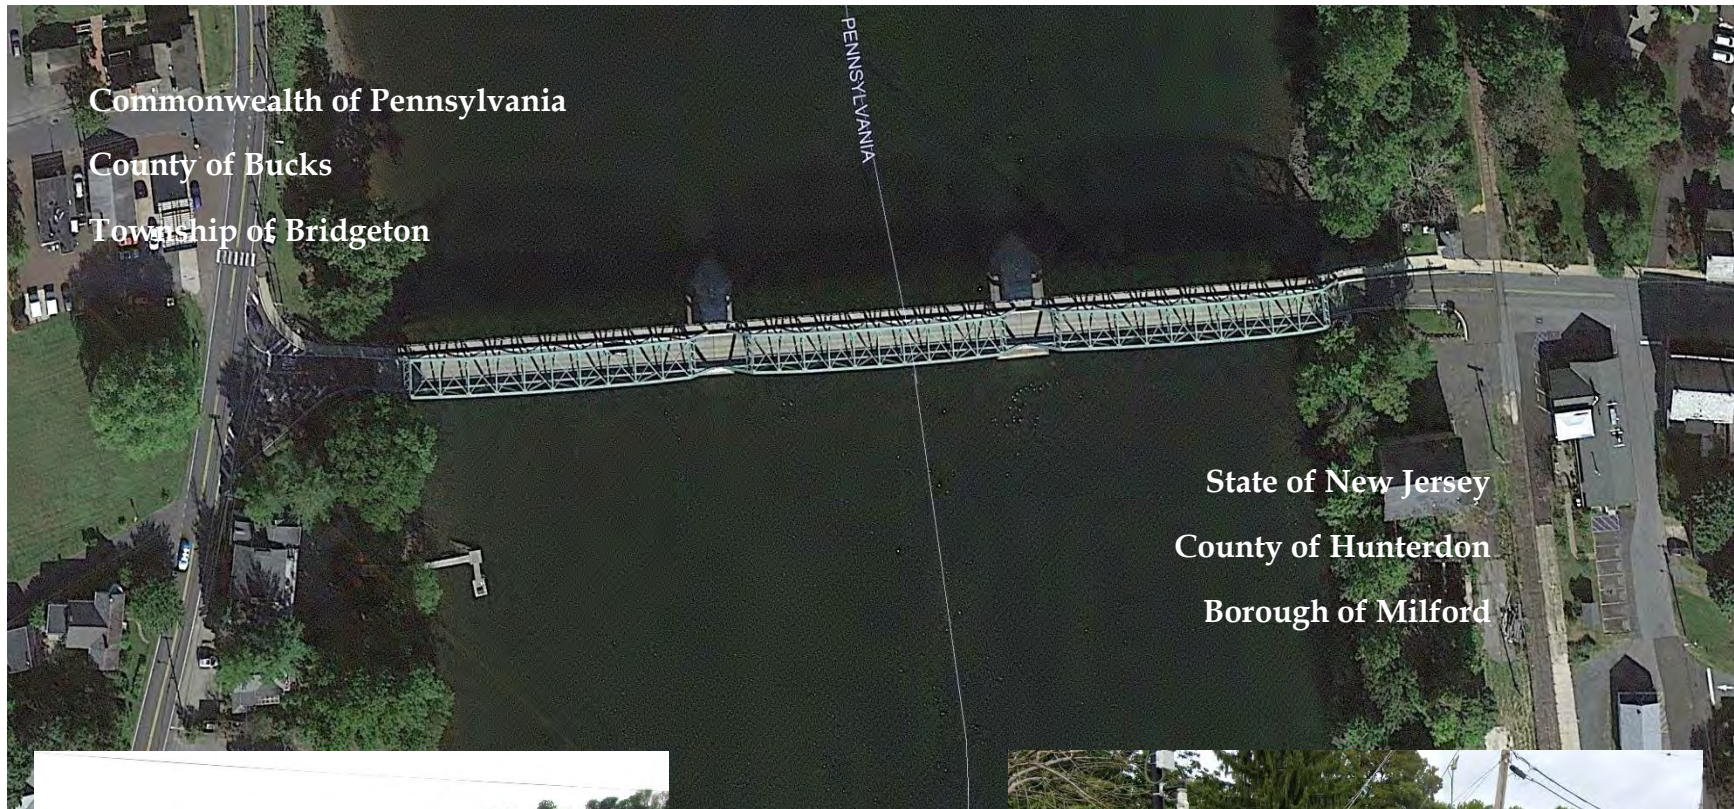
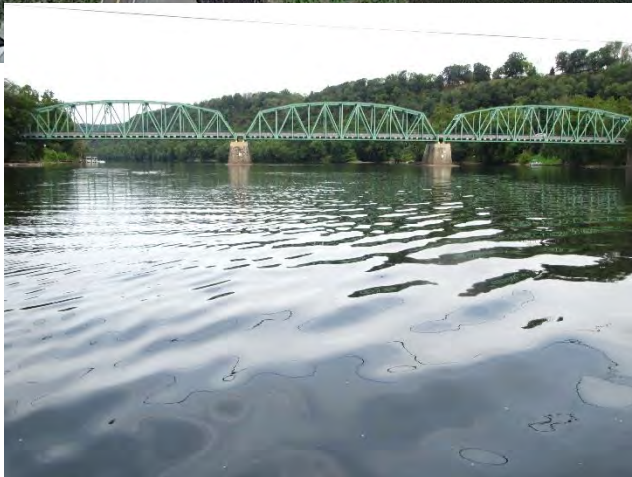
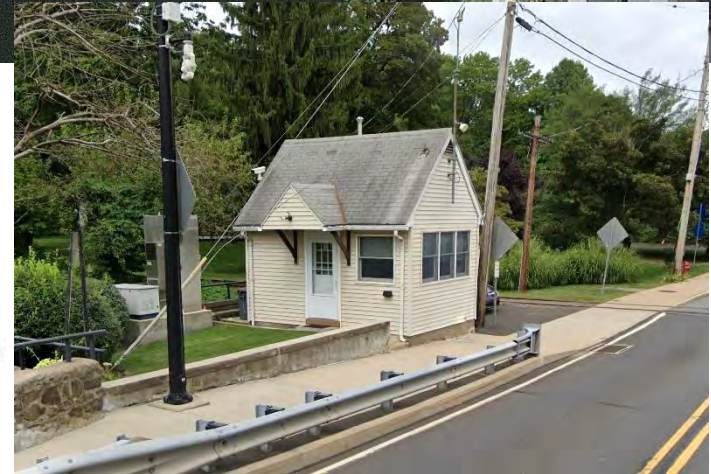
UPPER BLACK EDDY - MILFORD TOLL-SUPPORTED BRIDGE

The bridge, constructed in 1933, is a three span Warren Truss structure, with a total length of approximately 700 feet. The deck, replaced in 2011, consists of concrete filled steel inverted “T’s” and provides a curb to curb width of 20 feet. Both abutments, recapped with reinforced concrete following flood damage, were originally built in 1842 with rubble faced masonry. The piers, built in 1842, are stone filled having also been recapped with reinforced concrete.

The superstructure is in good condition. There are several minor areas of arrested pitting, localized corrosion, and pack rust throughout the truss members and gusset plates. Several lower chord batten plates and lower lateral bracing gusset plates have arrested section loss and holes.

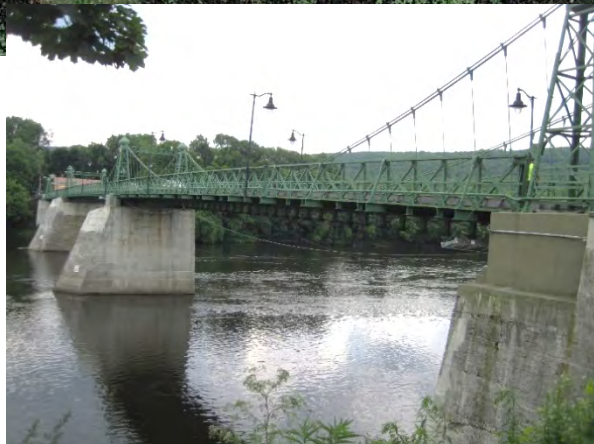
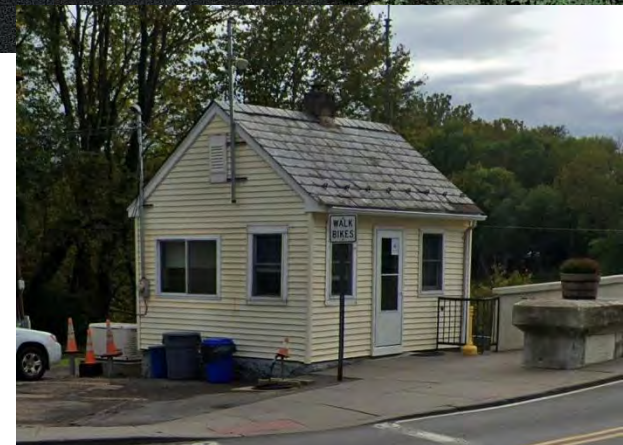
RIEGELSVILLE TOLL-SUPPORTED BRIDGE

The bridge, constructed in 1904, is a three span cable suspension bridge with straight backstays and a total length of approximately 581 feet. The open steel grid deck, supported by a king post floorbeam system, provides a curb to curb width of 15 feet 11 inches. A composite plank sidewalk rests on floorbeam cantilevers on both fascias. The flooring system is stiffened by steel trusses (Double Warren type) along the outside edges of the sidewalks. Stainless steel cables were added in 2010 to improve the trusses' functionality as pedestrian railings in addition to being primary superstructure members. The substructure, originally built in 1835, was raised and built up in 1904 to accommodate the present superstructure.

The superstructure is in good condition. Several holes were noted at the tower gusset plate connections to the base plates. Active rust with minor section loss was noted at a few of the hanger clamp attachments to the suspension cables at sidewalk level.

The substructure above the waterline is in fair condition. The substructure units exhibit medium to wide cracks, a few spalls in the concrete caps and scattered deterioration of mortar in the masonry pier stems and abutment wingwalls.
